Seismic resilience of road bridges: lessons learned from the 14 November 2016 Kaikōura Earthquake

A.I. Sarkis & A. Palermo
University of Canterbury, Christchurch, New Zealand

O. Kammouh & G.P. Cimellaro
Politecnico di Torino, Turin, Italy

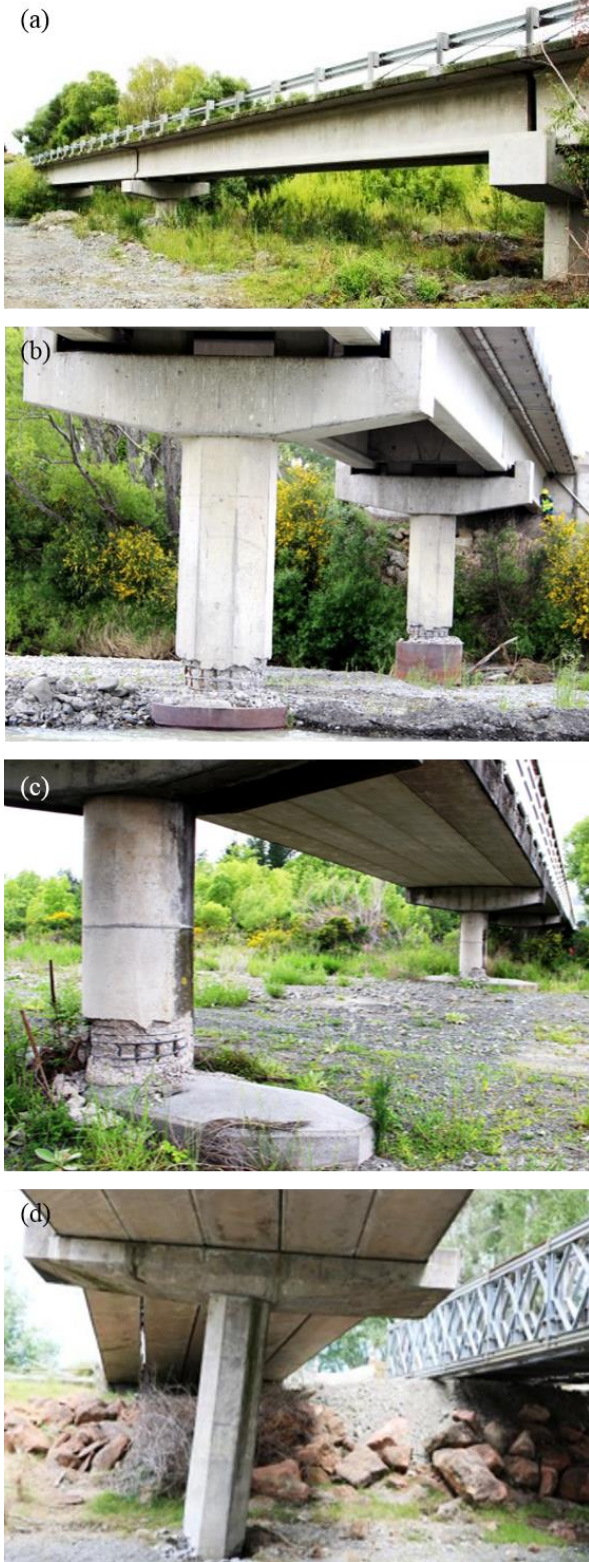
under transverse loading such that they can displace an appreciable amount on the supporting elastomeric bearings before contacting the shear keys. As a result, the bridges make use of the low lateral stiffness of the bearings to elongate the period of the structure. Figure 3. Bridges under study: (a) Lottery River Bridge; (b) Lower Mason River Bridge; (c) Mason River Bridge; (d) Wandle River Bridge (Palermo et al., 2017).

In the way they resist lateral loading, the Lottery River (Figure 3a) and Lower Mason (Figure 3b) bridges are identical. The transverse interaction has

Similarly, the Mason River Bridge (Figure 3c) is split in two with a central movement joint. There are transverse shear keys at the abutments and internal longitudinal shear keys and linkage bars over all of the piers except the central pier. At the central pier, provision is made for longitudinal movement with loose linkage bars but steel plate lateral support stubs cast into the piers restrain the transverse movement. Therefore, the overall transverse response can be thought of as the deck having a curved displaced shape where the largest transverse displacement occurs at the central pier (Palermo et al., 2017).

The Wandle River Bridge (Figure 3d) is curved in plan and has a slope in the longitudinal direction. Linkages, shear keys and elastomeric bearings restrain the transverse and longitudinal movement over the piers, but only linkage bars resist both the transverse and longitudinal movement at the abutments. Longitudinal movement towards the backfill at the abutments is resisted by the abutment back-wall which is cast against the beams.
